| CITY OF BALTIMORE WET SMOKE AND DYED | Page 1 of 3 | | | |
|--|---|---|--|--|
| Manhole ID: S19M035MH | Test ID: 1029-576 | Notifications Made:X_ Residents, Fire, 311 | | |

CITY OF BALTIMORE SMOKE TESTING OBSERVATION SUMMARY LOW LEVEL SEWERSHED

BALTIMORE CITY PROJECT 1029 REI/DRAYCO

| Unique Test ID: 576 | S Date | : 08/27/2008 | Basin: LL - 44 | Manhole ID: S19M035MH |

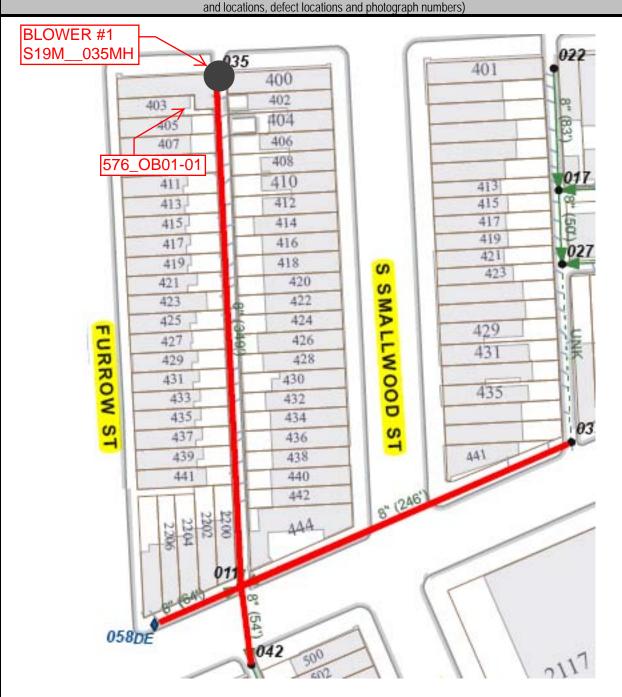
Field Sketch: (Show all manholes with numbers, blower placement location, sandbag or isolation locations, street names, building addresses and locations, defect locations and photograph numbers)

| CITY OF BALTIMORE WET WEATHER CONSENT DECREE SMOKE AND DYED WATER TESTING FORM | | | | | | Page 2 of 3 | | | | | | |
|--|---|--|---|---|--|---|---|---|---|---|---|---|
| 1 | 403 S FURROW ST. | | 09 | 14 | | 02 | | 0 | 03 | | | OB01-01.jpg |

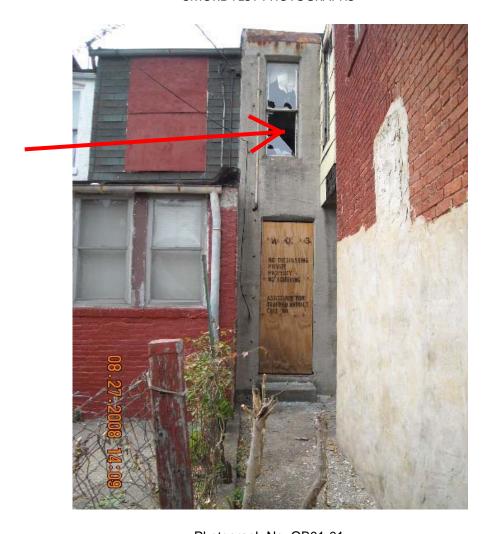
Photograph No: OB01-01 Filename: 1029-576_OB01-01.jpg

Location: 403 S. FURROW ST.

Source Type: 09 Building Interior Sector: 02 Private
Location: 14 Other Severity: 03 Moderate

Comments: SMOKE COMING FROM INTERIOR OF BUILDING.
